AC02-S21 Dogbone Correction

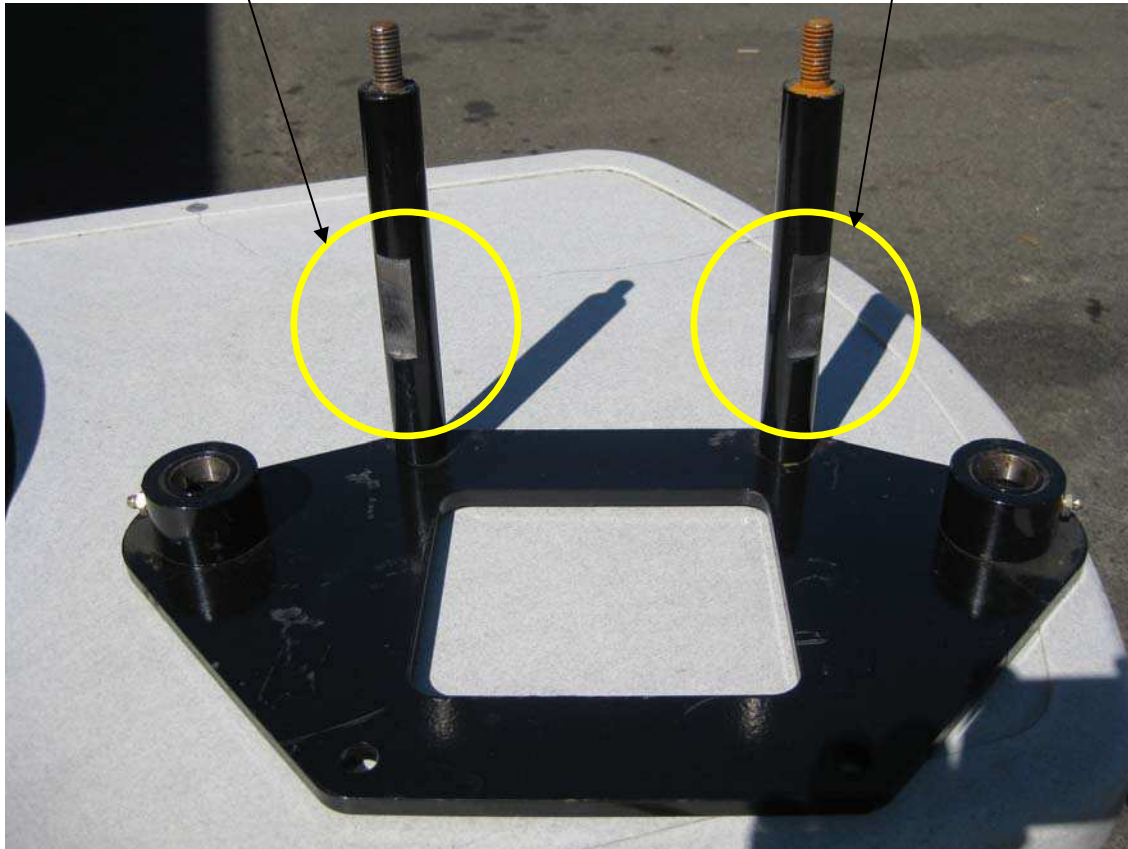
Old style –
arm on front
of container

New style –
arm on back
of container

- Issue: It is possible that the link assembly can impact the dogbone spacer causing the linkbar to fail prematurely. In addition, the new linkbar design is thicker requiring this correction to be completed before the new linkbar is installed.
- Correction: Grind spacer Part # AC02-114 1/8" as shown on the photo aside.
- Determine which spacer requires correction – see note on photo.
- To identify the area to grind, inspect the spacer where linkbar is hitting. Mark the area, remove dogbone and grind.
