Link Bar AC02-S22 Installation

Following this procedure will ensure that the link bar is installed correctly and adjusted properly. Failure to adhere to this procedure can result in:

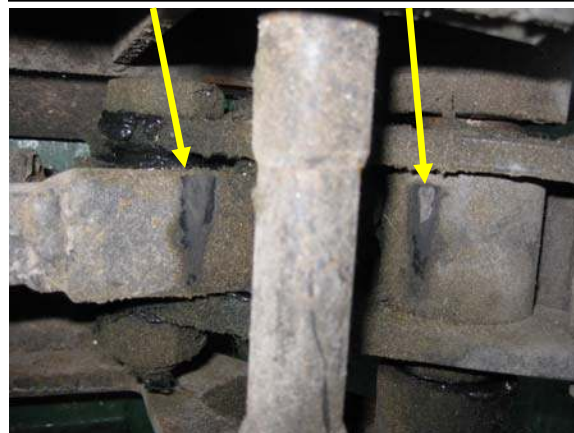
Interference Requires
Link Bar Adjustment

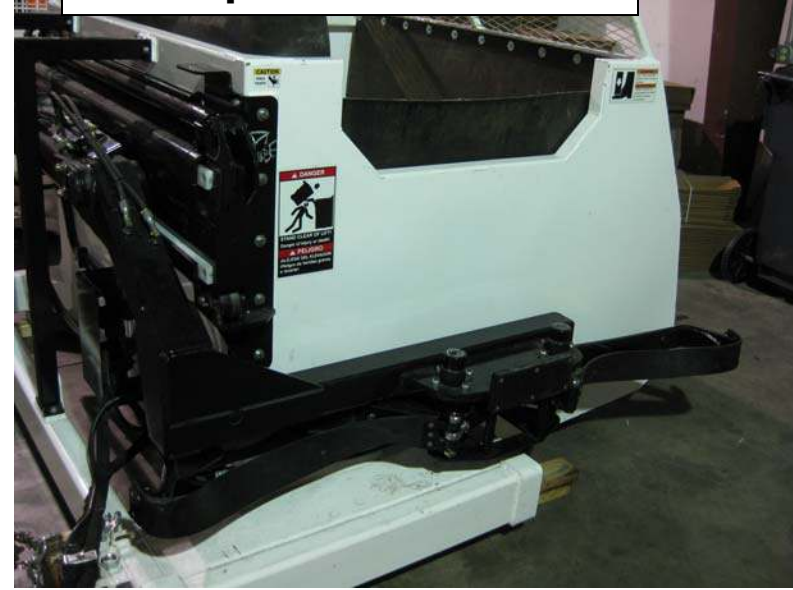
1. From the curb side operating position (if available), turn the truck on, safely activate the hydraulic system and curbside controls.
2. Run the grippers open and closed repeatedly. Observe the action of the grippers contacting the small rubber pads both forward and rear when grippers open to the home position.
3. The back of the grippers should impact the two small rubber pads simultaneously and without smashing or crashing against the pads. Also, note if the forward gripper is contacting the nose of the container
4. Note the results of the inspection, run the grippers to the closed position, Turn off the truck and pocket the key.

Open Position

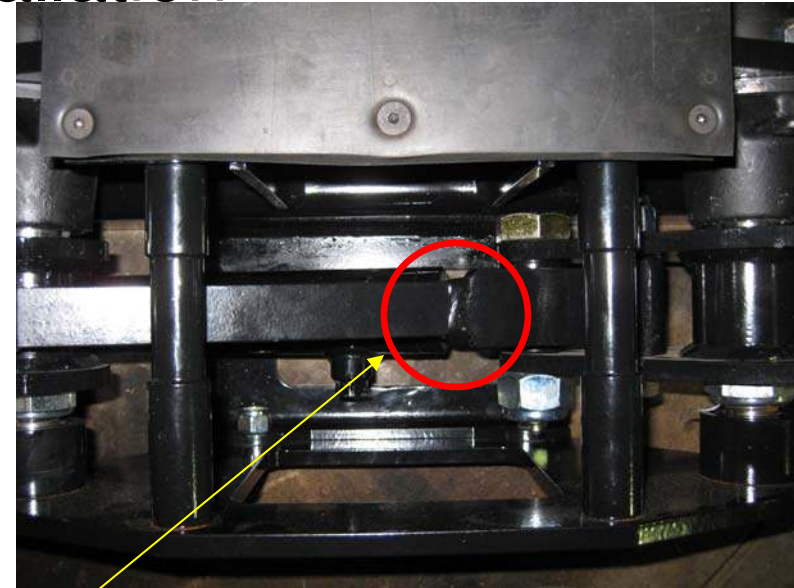
Inspect the link bar and ensure that the two piece welded “flat” surface is facing outward (curbside). This is the correct position. If the link bar is inverted, reposition the link bar to the correct position.

**Offset facing
inward -
Incorrect**

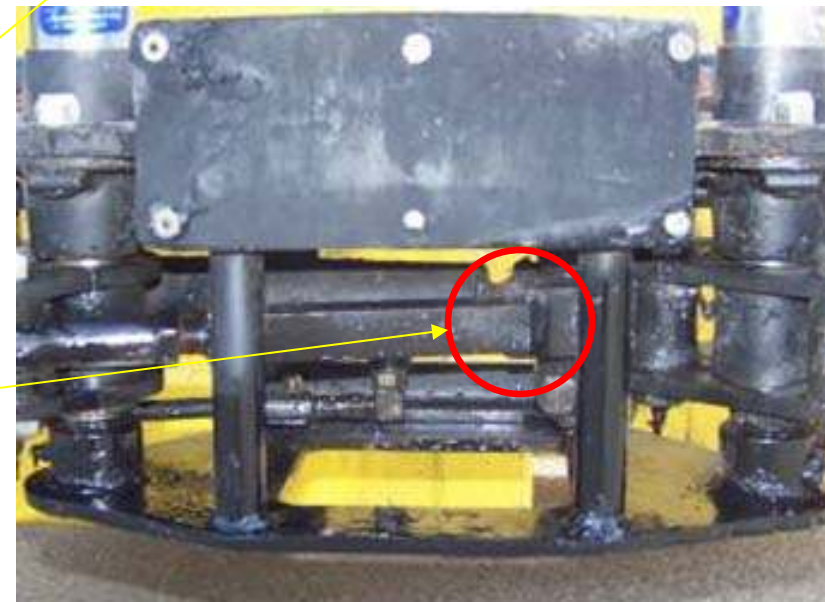
Improper installation – it is possible to install the link bar inverted (up side down)

**Offset facing
outward -
Incorrect**

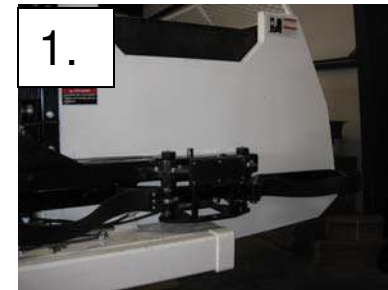
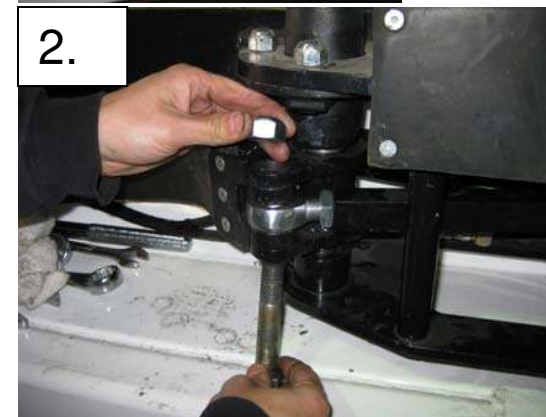
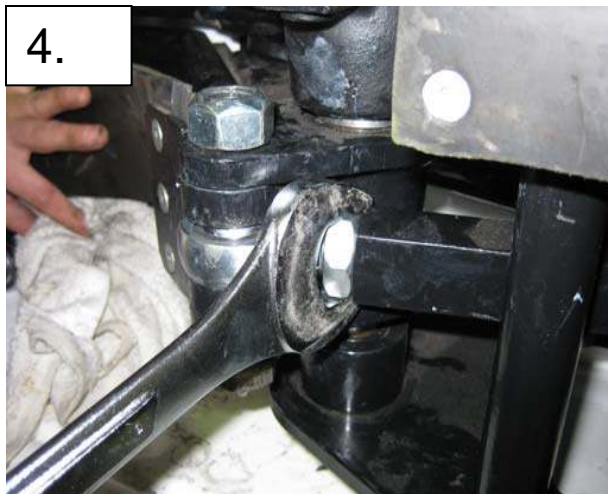
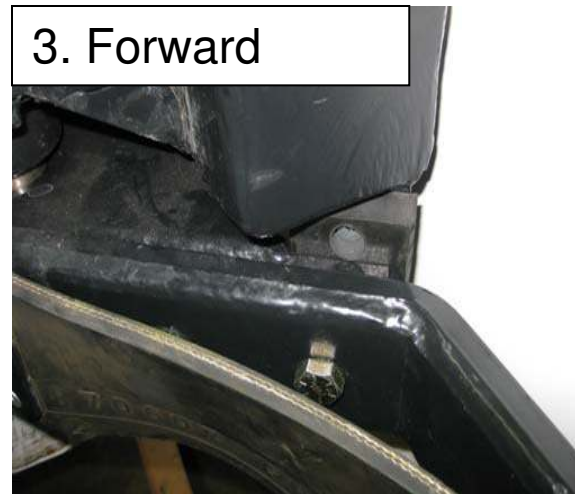
Link Bar Adjustment

1. Remove the Curotto Can from the truck with grippers open
2. Remove the hydraulic lines from the gripper cylinder CCP-S19
3. Remove AC4-A003 pin and place both grippers to the home position – resting against the small rubber pads – See Inset Note
4. Loosen jam nut FN-8075 on the rod end B17-0011

Ensure pads are in good condition. Using a nut on the counter sunk gripper bolt will ruin rubber pad and cause gripper to hyperextend.

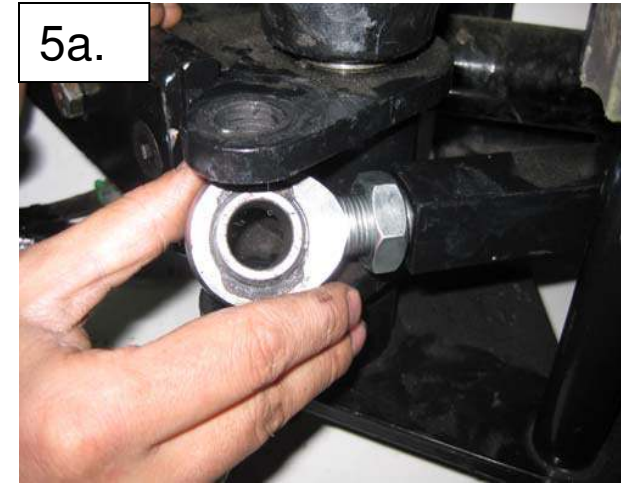
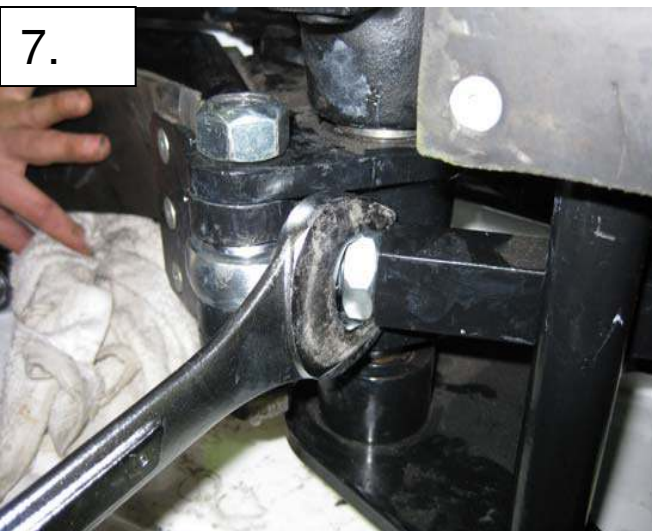
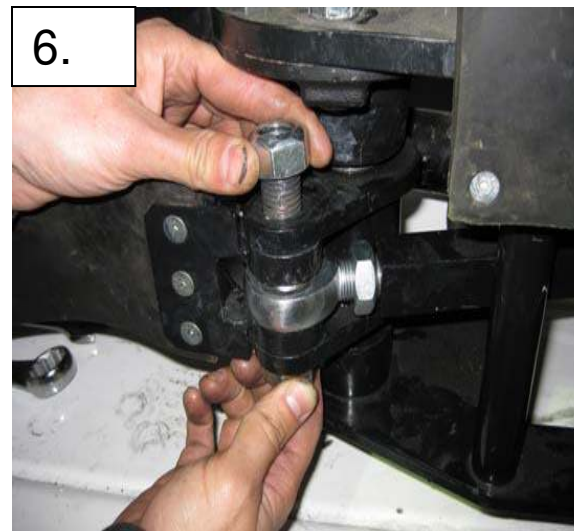
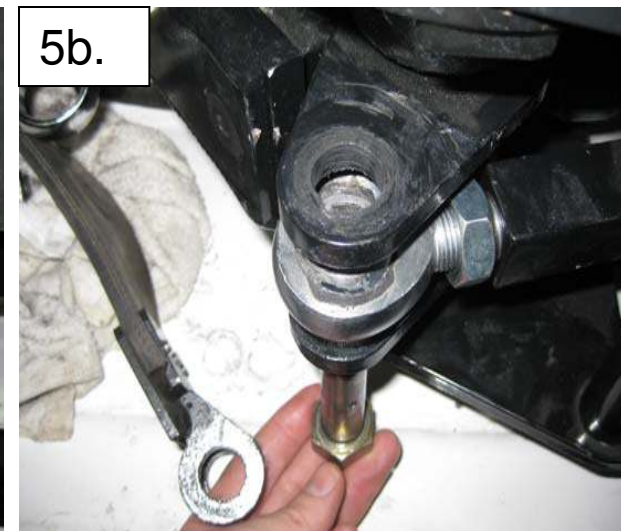
Link Bar Adjustment...(con't)

5. **Adjust the rod end to line up with the holes on the pivot bracket AC02-S34 making sure that both grippers are in the home position against the small rubber pads**
6. **Replace the AC4-A003 pin with buckle AC02-S23**
7. **Set jam nut on rod end**
8. **Replace hydraulic lines on gripper cylinder**
